## Introduction

- Examine the relationship between urbanization gradients, instream physical habitat, and aquatic macroinvertebrate assemblages to determine how improvement efforts have affected overall stream health in Galloway Creek.
- Explore the connections between alterations to the riparian corridor and in-stream physical habitat. This work comprises the beginning of a larger interdisciplinary effort to rehabilitate the Galloway Creek corridor as a functional ecosystem.
- We hypothesize that although reach-level improvements have been made, water quality and macroinvertebrate community composition quality will decrease as Galloway Creek flows through Menomonie.

- Galloway Creek is a small 2.6-mile-long spring-fed creek that flows through residential areas in Menomonie. Its headwaters are located south of Phelan Park and eventually drains into the Red Cedar River. The sub-watershed of Galloway Creek is approximately 777 hectares and heavily urbanized
- The Red Cedar watershed is located in west-central Wisconsin and drains 1,893 square miles.

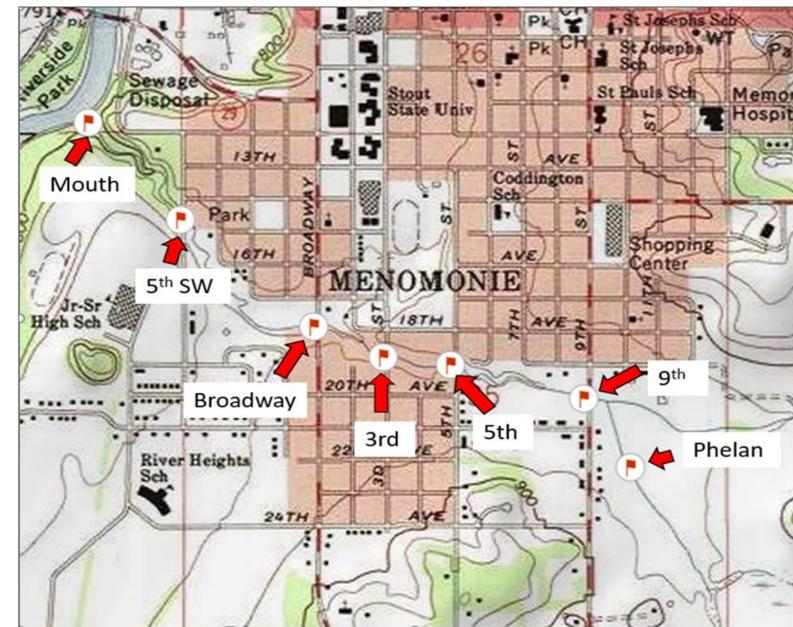
Figure 1. Map showing site locations of along Galloway Creek

- Seven sampling sites were identified and mapped along Galloway Creek representing an urbanization gradient from its headwater southwest of Menomonie to its mouth at the Red Cedar River (Figure 1).
- Sampling was conducted on October 11, 2019, September 6, 2020, then biweekly from March 5, 2021, to April 2, 2021.
- At each site, stream depth, width, turbidity, pH, conductivity, water temperature, air temperature, and flow rate were measured. Sampling followed UW-Extension Water Action Volunteers Stream Monitoring Network Protocols
- Macroinvertebrate sampling was conducted at each site in accordance with the type of habitat found at that particular sampling site (Hawkins et al., 1993)

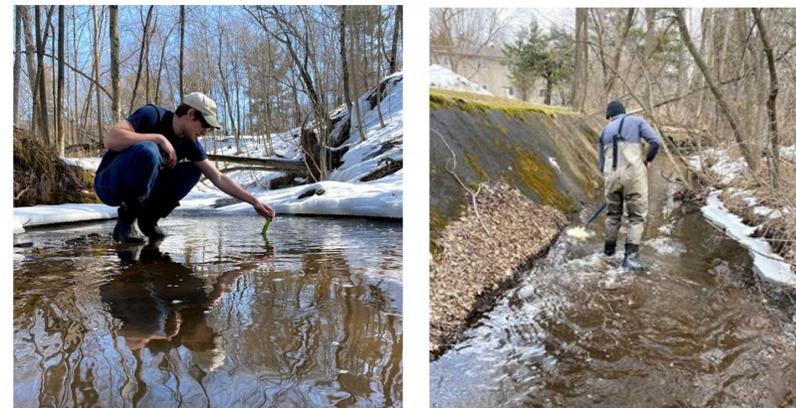
Figure 2. Spring 2021 conductivity sampling

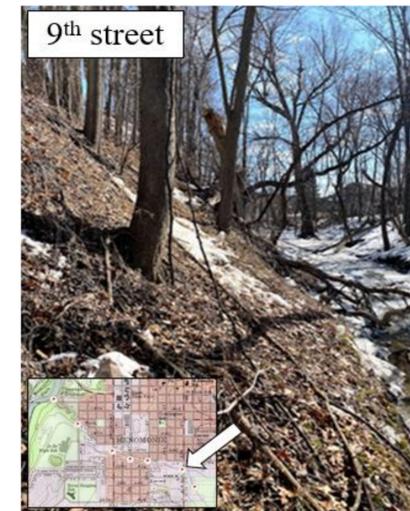
Figure 4. Extensive erosion is common in the corridor

- Riparian corridor quality along Galloway Creek is found to be of moderate-low quality. Common Buckthorn, Bush Honeysuckle, Garlic Mustard, Dames Rocket, Black Locust were all identified in the City of Menomonie owned land by 5th St. SW (Galloway Creek Community Restoration Project).

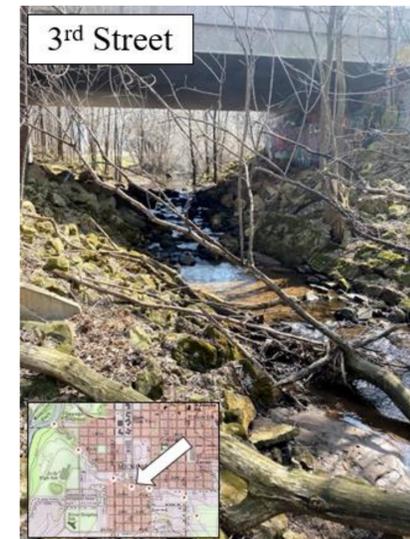
Figure 5. Failing WPA channelization project

- Macroinvertebrate community data showed evidence of taxon with high pollutant tolerance.
- Large remnant pieces of channelization are located along Galloway Creek. The creek was first channelized during WWII through the Works Progress Administration program, with large concrete sections being poured from the 9th street site down to the mouth.

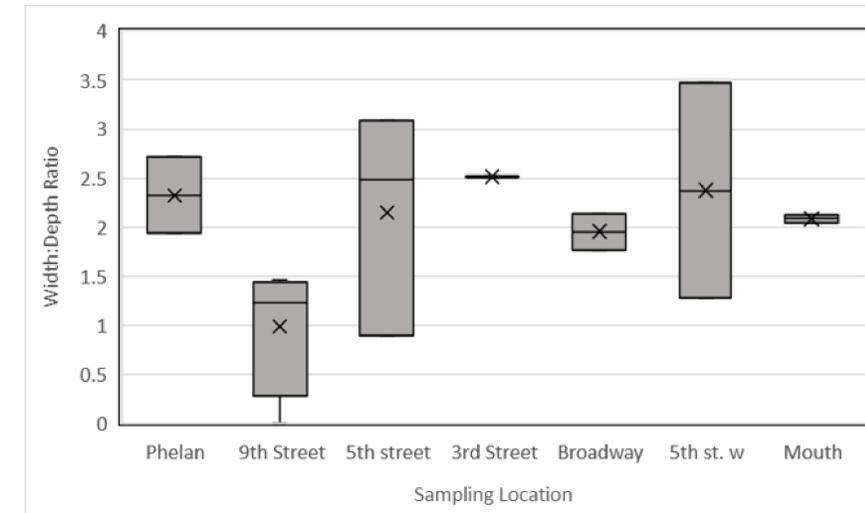
Figure 7. Box and Whisker Plot of width:depth ratio

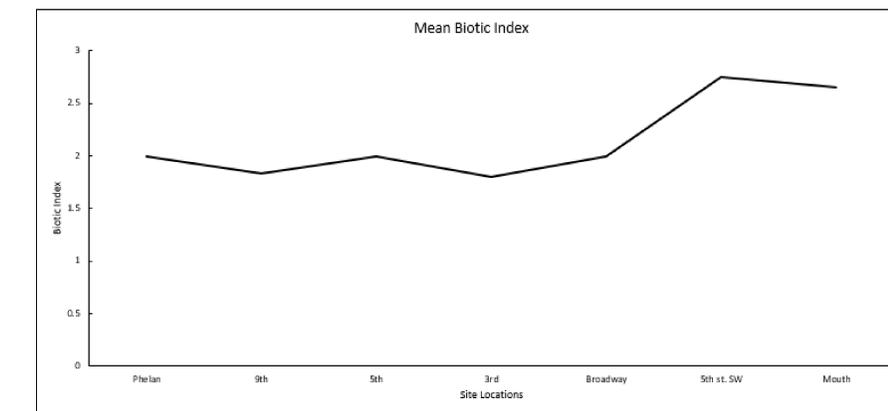
Average biotic index= 2.14

Quality	Biotic Index Range
Excellent	3.6+
Good	2.6 - 3.5
Fair	2.1 - 2.5
Poor	1.0 - 2.0

Figure 8. Line graph showing Biotic Index across sites.

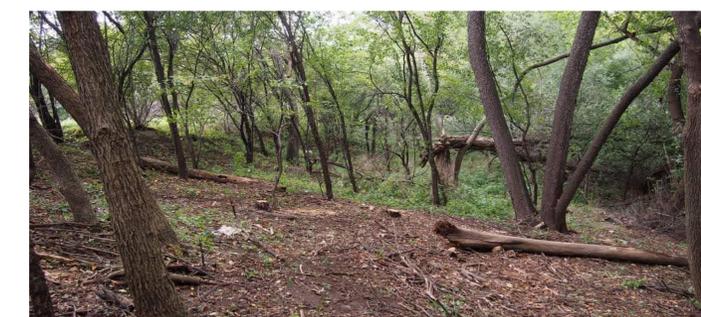
Figure 9. A new reach-level corridor restoration project is being implemented between 5th st. W and Broadway

- Corridor restoration is beginning on a new reach Fall 2021
- If restoration is effective at improving degraded urban stream ecosystems, both the geomorphology and biota at restored sites would more closely resemble forested sites than would their urban counterparts (Violin et al. 2001)
